Identify the Causes and Environmental Friendly Methods to Control Eutrophication in Vavuniya Tank, Sri Lanka

P. Loganathan[#], A. Manjceevan and G. Naveendrakumar

Department of Bio-Science, Faculty of Applied Science
Vavuniya Campus, University of Jaffna

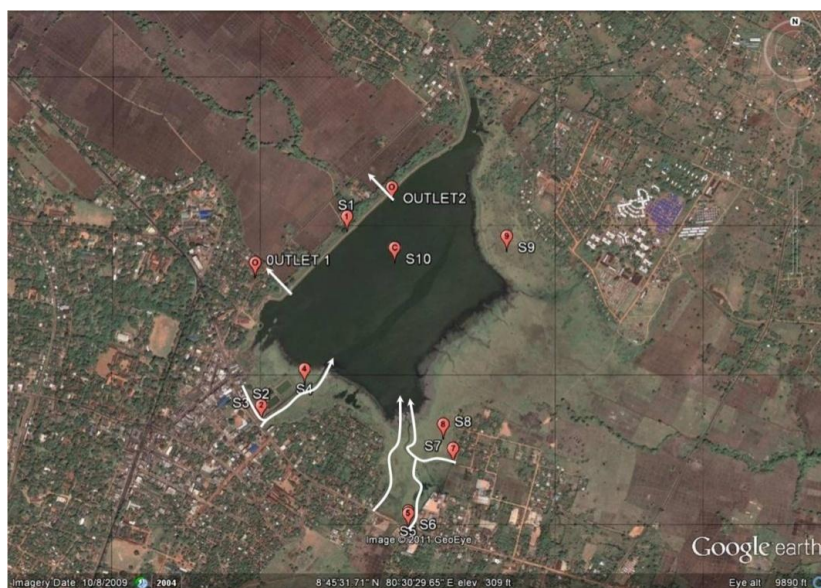
Figure 1: Sample Locations

Water samples were collected from 12 various locations (Figure 1) in Vavuniya tank using water sampler at the depth just below the water surface. Locations were marked by coordinates using GPS (Table 1). Samples were collected once in two months from July to November 2011.

The study site Vavuniya tank is an aquatic body lies within the Urban Council limits of Vavuniya district. It is located in between N8°45'13.75-53.21" E80°30'7.50-59.23" geometrically. Wastewater and storm waters enter into tank through different drains which carry lot of nutrients (Nitrogen and Phosphate) from Industrial wastewater (S5, S6, S7 & S8), hotel wastewater (S2, S3, S4) and commercial wastewater (S3).

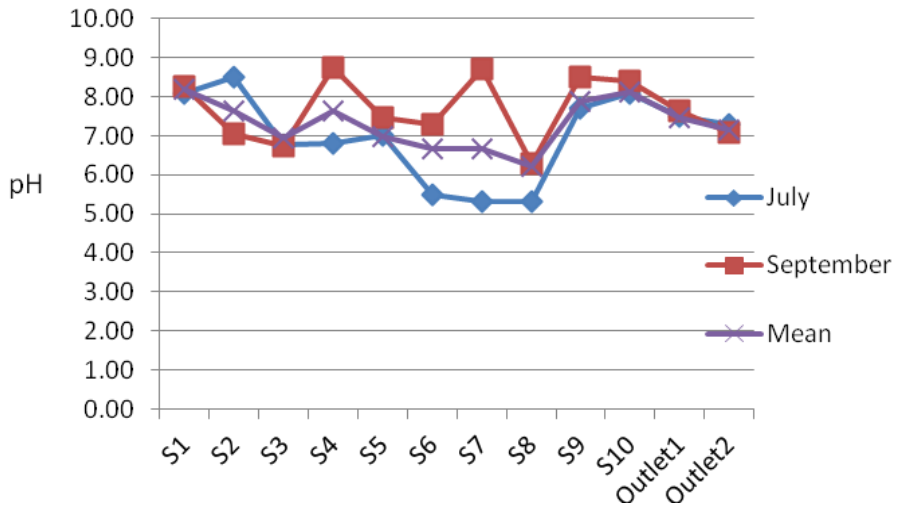
Figure 2: Temporal and spatial variation of pH in collected water sample

The pH of the sampled water varies from 5.33 to 8.51 from July to November (Figure 2). Samples S1, S2, S3, S4, S9, S10, Outlet1 and Outlet2 showed pH within the permissible limit of 6.5–9.0 (WHO, 1984) irrespective of the months. But S6 (Industrial wastewater), S7 (Industrial wastewater) and S8 shows pH value below 6.5 in July 2011 and water is slightly acidic. This range is not good for crop cultivation but pH value in Outlet 1 & 2 was within the WHO permissible limits due to mixing of water. Therefore, development of acidification in Vavuniya tank should be minimized by disposing industrial wastewater after treatment to control the development of acidity in Vavuniya Tank.

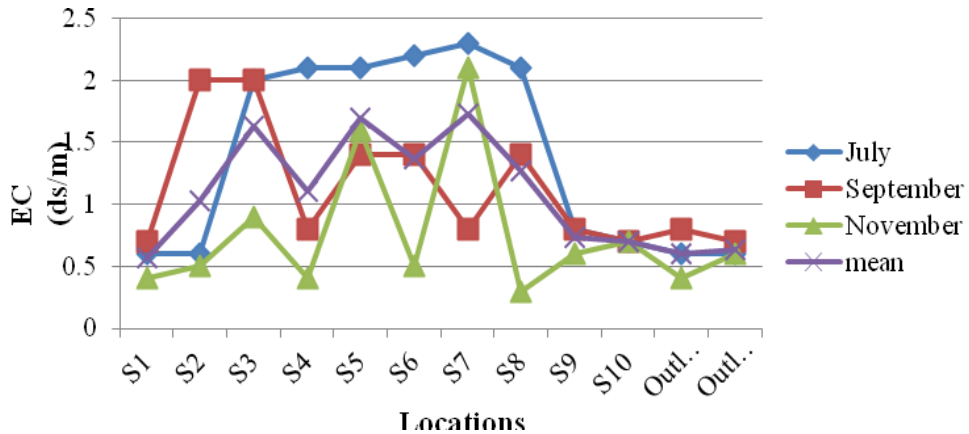
Figure 3: Temporal and spatial variation of EC in collected water sample

Mean EC of water sample ranged from 0.57 to 1.53 ds/m^{-1} and it was within the permissible limit of 3.5 ds/m^{-1} (WHO, 1984) for drinking water. Therefore water could be used for drinking purpose without any health hazards in relation to dissolved salts. Electrical Conductivity of Centre of the tank (S10), Outlet 1, Outlet 2, East side of tank (S9) and Centre of tank bund of North (S1) were below 1.00 (0.8ds/m) for most crops. Rainy season (during November) value was significantly

EC values were higher than desirable level for irrigation in locations S3, S5 & S7 (Figure 3) but water flow/movement of water in tank diluted these value as the EC value at outlets were near to the desirable level. Therefore, tank should be managed well to prevent further rise of EC level due to disposal of wastewater with solid particles/disposal of wastewater directly to tank without pass through oxidation pond. dsm^{-1} , in all seasons and these values were slightly lower than desirable level.

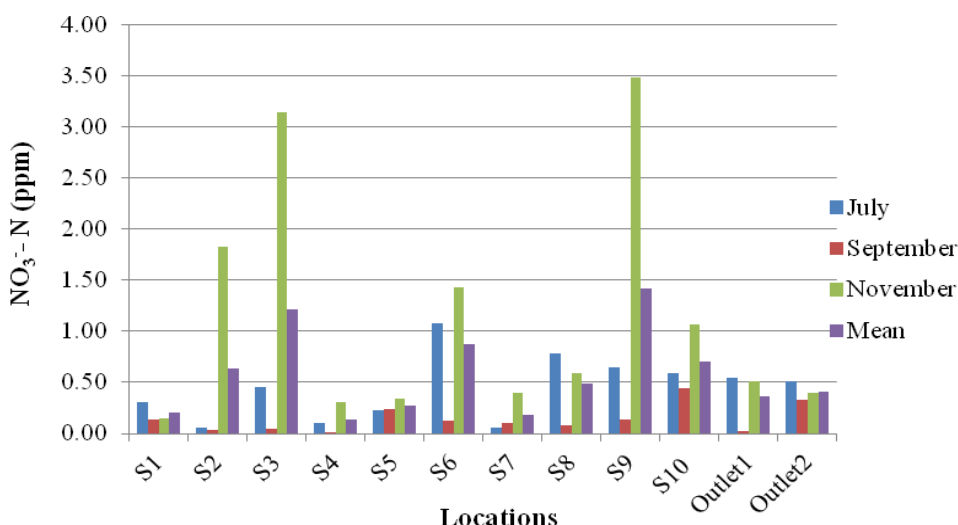
Figure 4: Temporal and spatial variation of NO₃⁻ in collected water samples

The NO₃⁻ ranged from 0.01 to 3.48 ppm from July 2011 to November 2011 and all sample values were below the permissible limit of 10 ppm of WHO drinking water standard. NO₃⁻ in November was significantly ($p=0.053$) higher than July (Figure 4) value due to run off water from different lands (agricultural land, waste disposed land, etc) after heavy rain. The NO₃⁻ value in S3 and S9 were higher than other locations in November 2011.

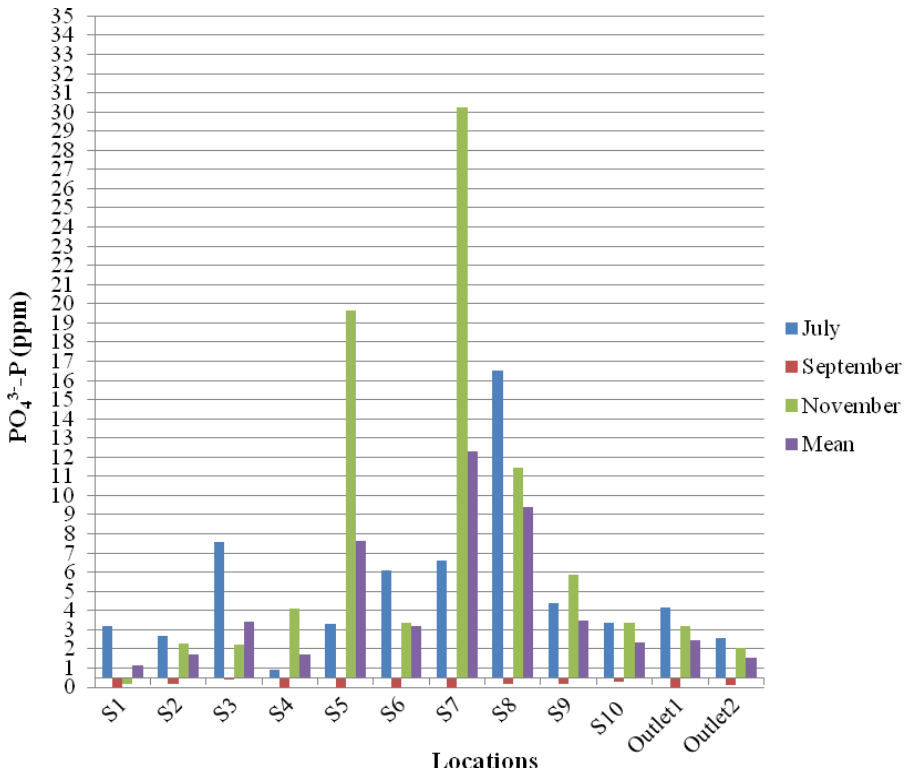
Figure 5: Temporal and spatial variation of Po_4^{3-} in collected water sample

The PO_4^{3-} ranged from 0.01 to 30.23 ppm from July 2011 to November 2011. All the sample values except S4 were above the permissible limit of 2 ppm of WHO drinking water standard in July 2011 and also all the samples except S1 were above 2 ppm in November 2011 (Figure 5).

According to literature, in aquatic ecosystem, when exceeding 0.1 mg phosphorus per liter, biodiversity often declines with time. Samples S3, S5, S6, S7 and S8 showed higher PO_4^{3-} value than other locations. These are main non-point source of pollutant to Vavuniya tank. There was no significant different in PO_4^{3-} in November and July 2011. The runoff of nitrate and phosphate into tank causes accelerated eutrophication.

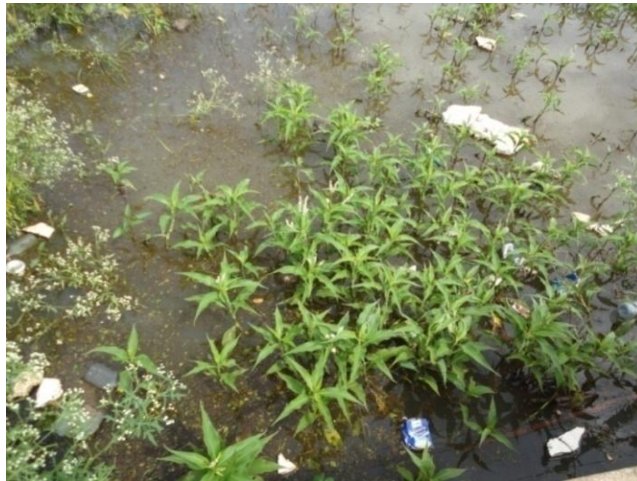
Figure 6: Eutrophication species Polygonum barbatum

Second abundant species in Vavuniya tank is *Polygonum spp.* It is terrestrial or aquatic, perennial, erect herb, and grow up to 200 cm long. It reproduces by seeds and it is a weed in agricultural fields. Therefore agricultural field can be infested by these weed's seed during irrigation. Hence immediate action has to be taken to eradicate these weeds in Vavuniya tank. Queen Rosary Sheela (2011) showed in India that *Polygonum barbatum* has antimicrobial activity and leaf extract is a broad spectrum agent which can be used against gram negative and gram positive bacteria and also fungi. Further study has to be carried out to confirm the antimicrobial effect of above weeds in Sri Lanka to be used as bio-pesticide.

Fishing community said that they use to remove mat of plants manually when they observe a lots of mats in the tank (Figure 6). Therefore mat of plant should be removed when they observe in small in size as it is easy to remove and also to prevent further spreading. Fishing community further said that Irrigation department also uses to remove mats in every Wednesday. Therefore, Irrigation Department has to confirm the eradication of *Eichornia crassipes* and *Polygonum barbatum*. And also Irrigation Department has to confirm the flow of domestic drains to Vavuniya tank through oxidation pond to minimize the accumulation of waste into tank to reduce nitrate and phosphate pollution from non point source and confirm the regular function of oxidation pond.

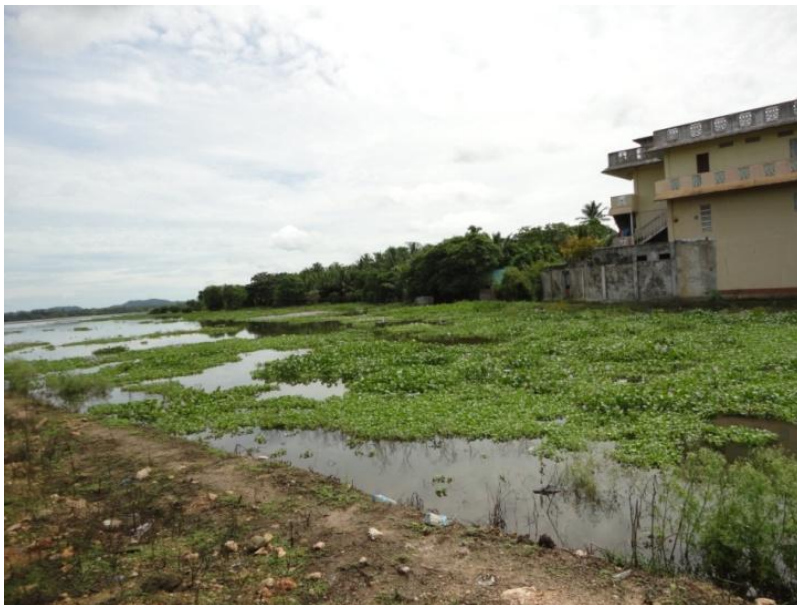
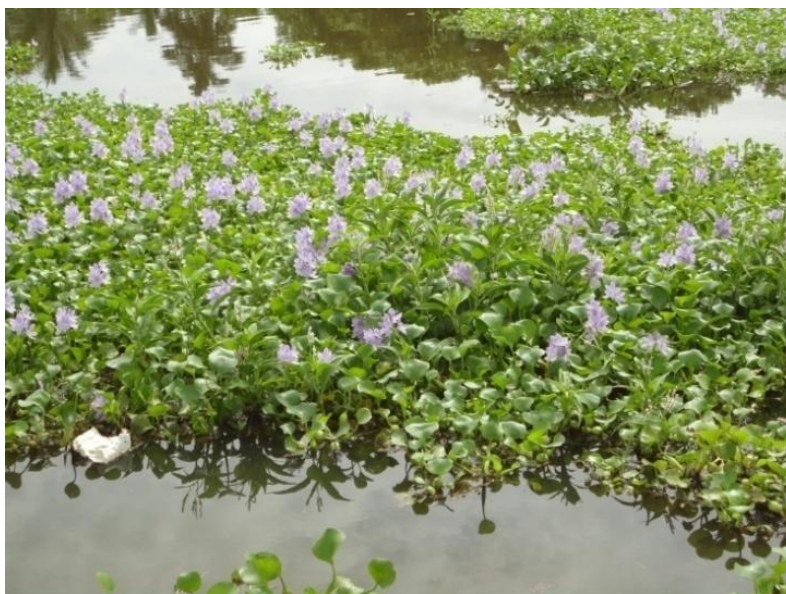
**Figure 8: Prevailing situation in Vavuniya Tank –
Eutrophication species Water hyacinth**

Water hyacinth is first abundant species in Vavuniya tank. Water hyacinth is a perennial aquatic weed that is usually free-floating. The plant reproduces by seeds and vegetative through daughter plants that form on rhizomes and produce dense plant beds.

According to fishermen, fishing nets are being damaged by water hyacinth but damage was less when comparing with 2-3 years back, as they use to remove the water hyacinth manually when they observe large mat of water hyacinth in tank. Accordingly, the Irrigation department performs the removal activity during Wednesdays in a week. Further they said that they had skin allergies in hand and legs after participating in a removal activity of water hyacinth.

Manual removal of water hyacinth is very labor expensive and time consuming as they consist 90 % of water in it. Misra and Tripathy (1975) reported that mechanical method of control is costly in time, money and energy and several of the procedures used damaged the ecology, affecting all animal life in the aquatic ecosystem infested by the hyacinth. Therefore removal should be done when they are in a small mat to prevent detrimental effect. Removed mat can be incorporated in a compost preparation.
